## Hazardous Building Materials Assessment

*Demolition, Former Military-Use Building*

Building T-2058  
APN: 031-221-005-000  
Former Fort Ord  
Marina, California

Date: February 22, 2021

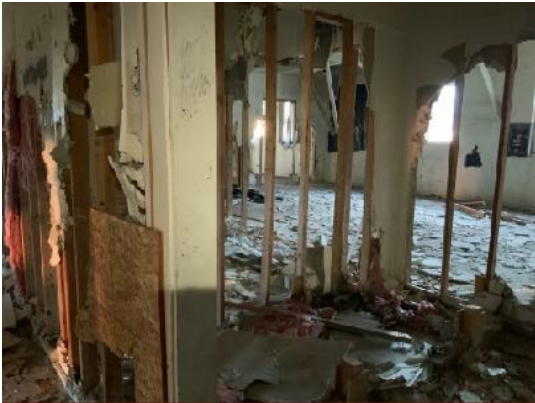
- \* The taping compound, associated with the drywall throughout the building, contains up to 0.3% Chrysotile asbestos, confirmed by 1000 point count analysis. Drywall walls and ceilings have been heavily vandalized, resulting in commingling with other interior debris, throughout the building. All remaining intact drywall and drywall impacted debris is classified as Asbestos Containing Construction Materials (ACCM).

<p>ACCM Damaged Drywall On Walls &amp; Commingled With Debris On The Ground</p> </div> <div style="text-align: center;">

Third party contractor oversight, air monitoring, and final clearance inspections should occur during the removal of the ACCM drywall. If the ACCM will be demolished in-place, perimeter air sampling should occur to document the demolition related work did not create an airborne asbestos hazard.

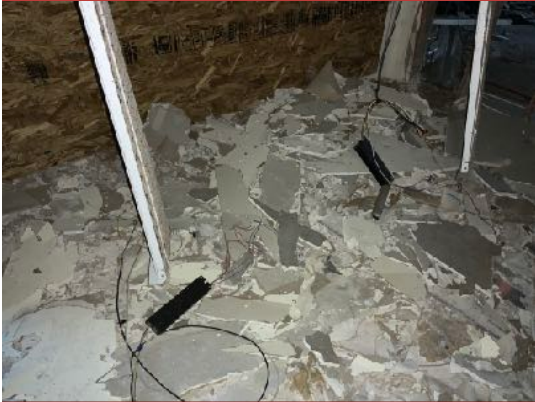
<p>ACCM Drywall Debris Commingled With Debris On The Ground</p> </div> </div>

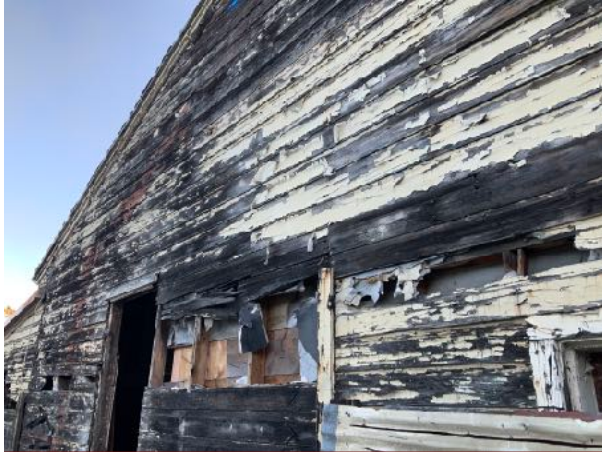
Defective Lead-Based Paint On Exterior Painted Wood Components

- \* **Exterior painted wood must be disposed of as RCRA Hazardous Waste.**
- \* **Interior painted may be disposed of as non-hazardous construction waste.**
- \* **Painted drywall may be disposed of as non-hazardous construction waste. Note, very low asbestos content is present in the drywall and should be handled accordingly.**

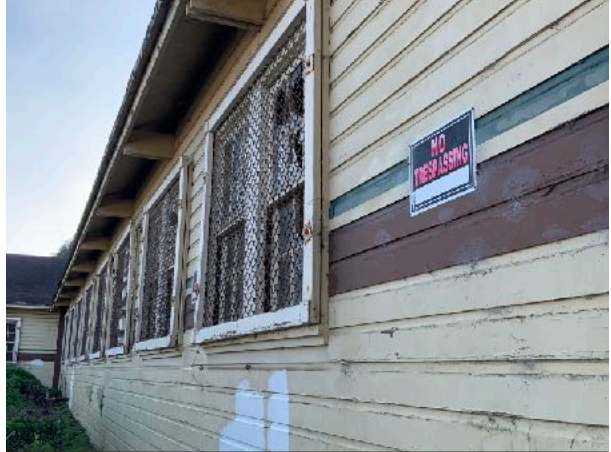
Defective Lead-Based Paint On Exterior Siding & Window Components

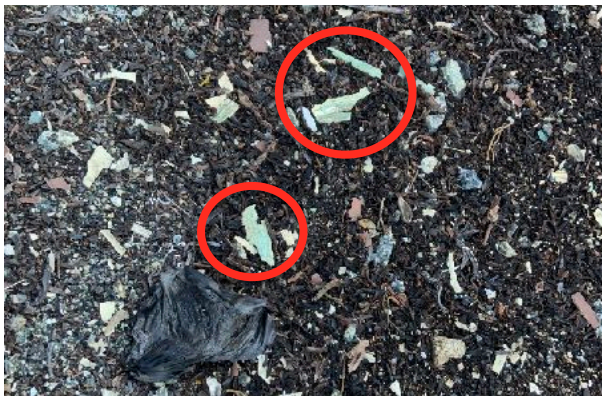
Paint Chips With Lead-Based Paint Present In The Soil Near The Building

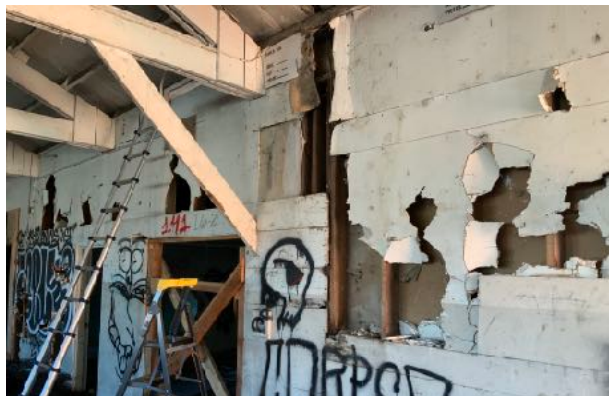
Warehouse Area - Defective Lead-Based Paint On Wood & Drywall, Walls & Ceilings

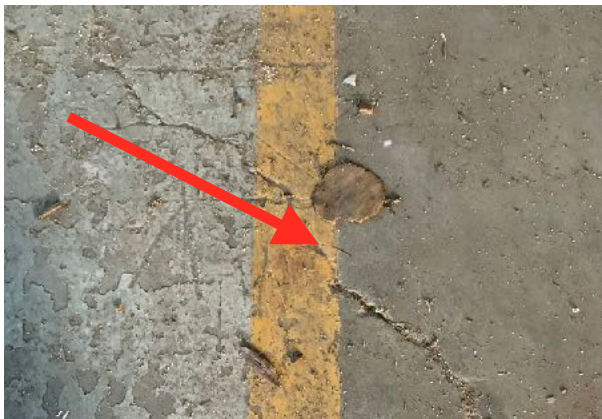
Warehouse Area - Yellow Striping With Lead-Based Paint On Concrete

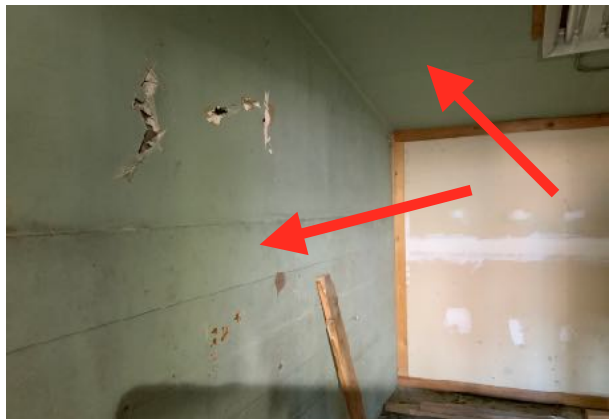
Storeroom #1 - Lead-Based Paint On Walls & Ceiling

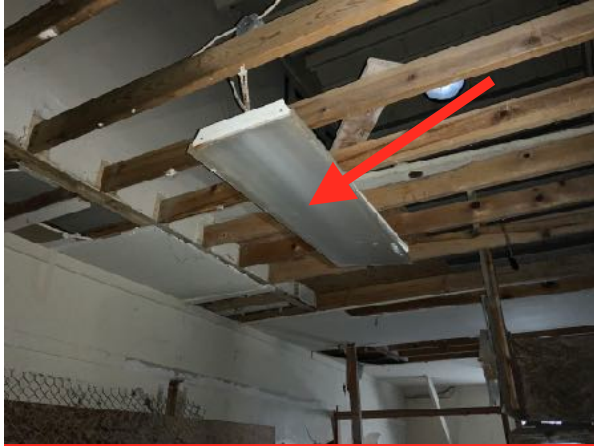
- \* The building has fluorescent light fixtures, containing mercury containing fluorescent tubes and suspect PCB containing ballasts.
- \* A variety of household hazardous wastes are stored within the building.

Fluorescent Tube Fixture

As part of the pre-demolition environmental remediation, all fixtures and items identified in this report to contain hazardous properties must be segregated from the general non-hazardous waste stream. Items should be handled, packaged, and disposed of accordingly to remain in compliance with DTSC and other local, state, and federal requirements. The owner must be provided copies of all waste manifests.

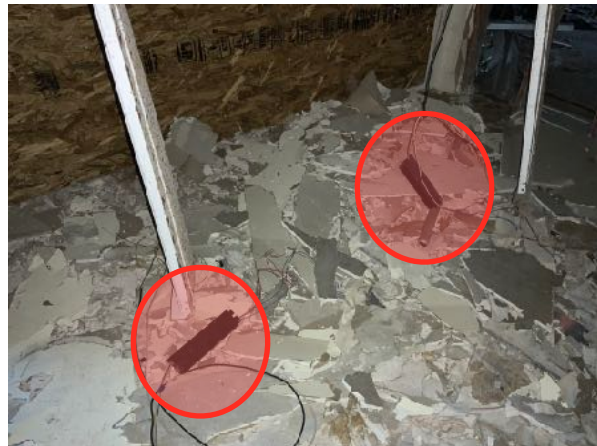
Suspect PCB Ballasts (On The Ground)

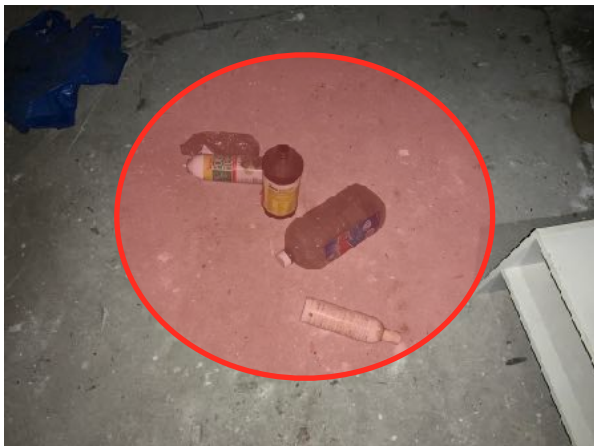
Miscellaneous Household  
Hazardous Waste
