## Limited Asbestos Survey Report

### *Demolition, Commercial Property*

Site: APN 031-221-003-000, Building 2060 & 2061, Former Fort Ord, Marina, California

S Tech Project: 21087-4

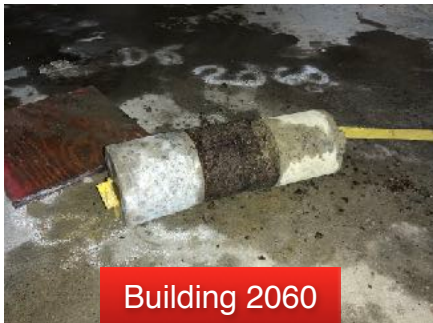
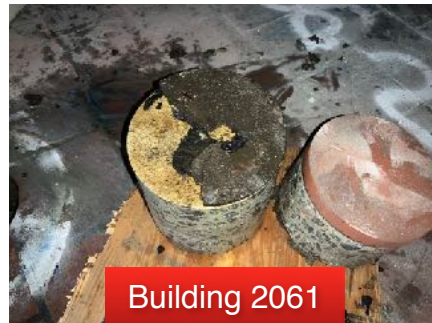
Buildings 2060 and 2061 functioned as cold storage facilities for food services, during the time Fort Ord was an active military base. Exploratory concrete coring determined cork insulation under the concrete foundation slab of building 2060 and fibrous insulation under the concrete foundation slab of building 2061. Both insulation types have black waterproofing mastic above and below the insulation layers. Both buildings have a secondary concrete foundation slab under the insulation layers.

- \* **Asbestos was not identified in the materials under the concrete slabs of buildings 2060 & 2061.**

Asbestos was not identified in the insulating materials and associated mastics under the concrete slabs of buildings 2060 and 2061. No further action, with regards to asbestos, is necessary to proceed with the demolition scope of work with regards to these materials. However, other materials containing asbestos have been identified at the site. Contractors should refer to the pre-demolition hazardous building materials assessment reports for a complete listings of all hazardous building materials identified at the site. Should any additional suspect materials be identified during the course of the demolition work, stop work and contact us to assess and sample if necessary.
