PHASE I ENVIRONMENTAL SITE ASSESSMENT AND LIMITED PHASE II SOIL TESTING MONTEREY-SALINAS TRANSIT SOUTH COUNTY OPERATIONS AND MAINTENANCE FACILITY KING CITY EAST RANCH BUSINESS PARK, APN 026-521-031 KING CITY, CALIFORNIA

File No.: SH-13325-EA

Report of Phase I Environmental Site Assessment and

Limited Phase II Soil Testing

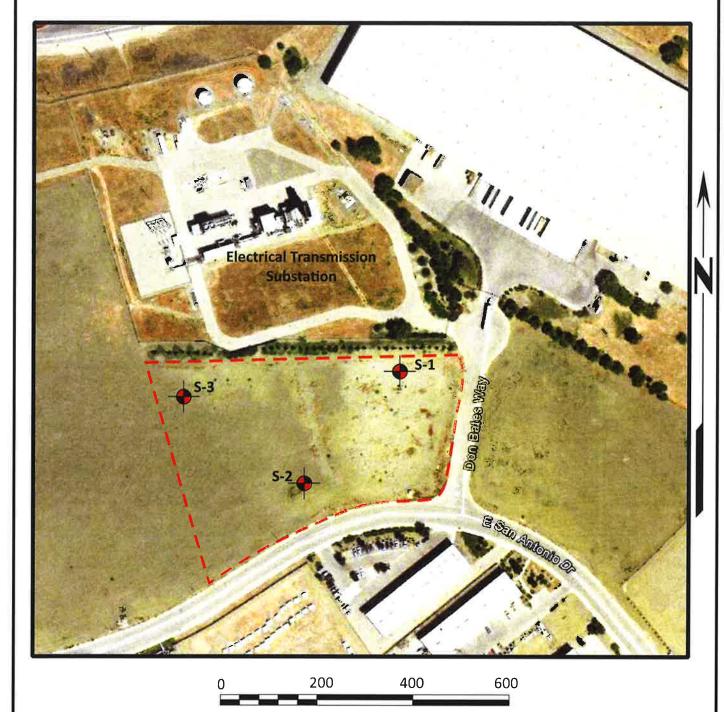
Approximate Scale in Feet

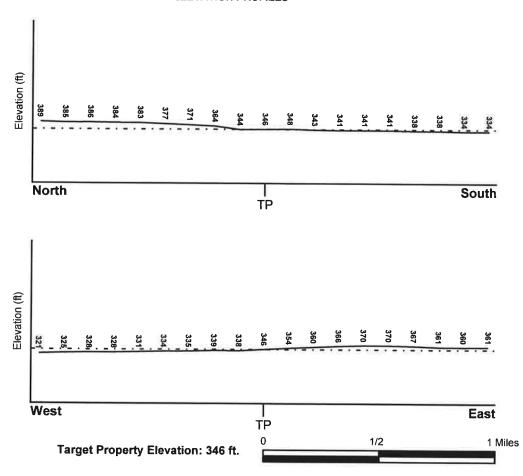
SURROUNDING TOPOGRAPHY: ELEVATION PROFILES

General Topographic Gradient: General SW

Source: Topography has been determined from the USGS 7.5' Digital Elevation Model and should be evaluated on a relative (not an absolute) basis. Relative elevation information between sites of close proximity should be field verified.

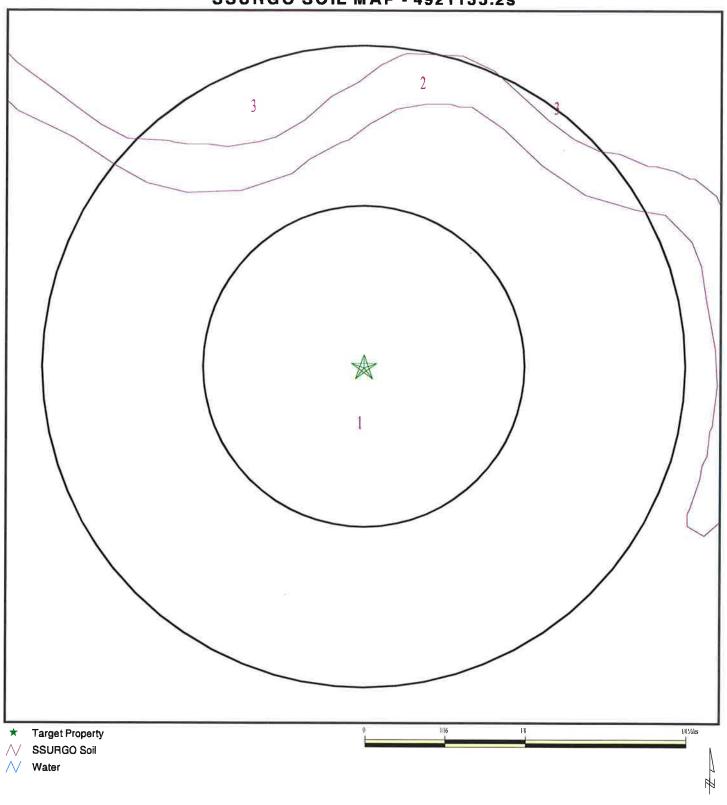
SSURGO SOIL MAP - 4921135.2s

Class B - Moderate infiltration rates. Deep and moderately deep.

Corrosion Potential - Uncoated Steel High

Class D - Very slow infiltration rates. Soils are clayey, have a high

Corrosion Potential - Uncoated Steel: High
