## Hazardous Building Materials Assessment

*Demolition, Former Military-Use Building*

Building T-2058  
APN: 031-221-005-000  
Former Fort Ord  
Marina, California

Date: February 22, 2021

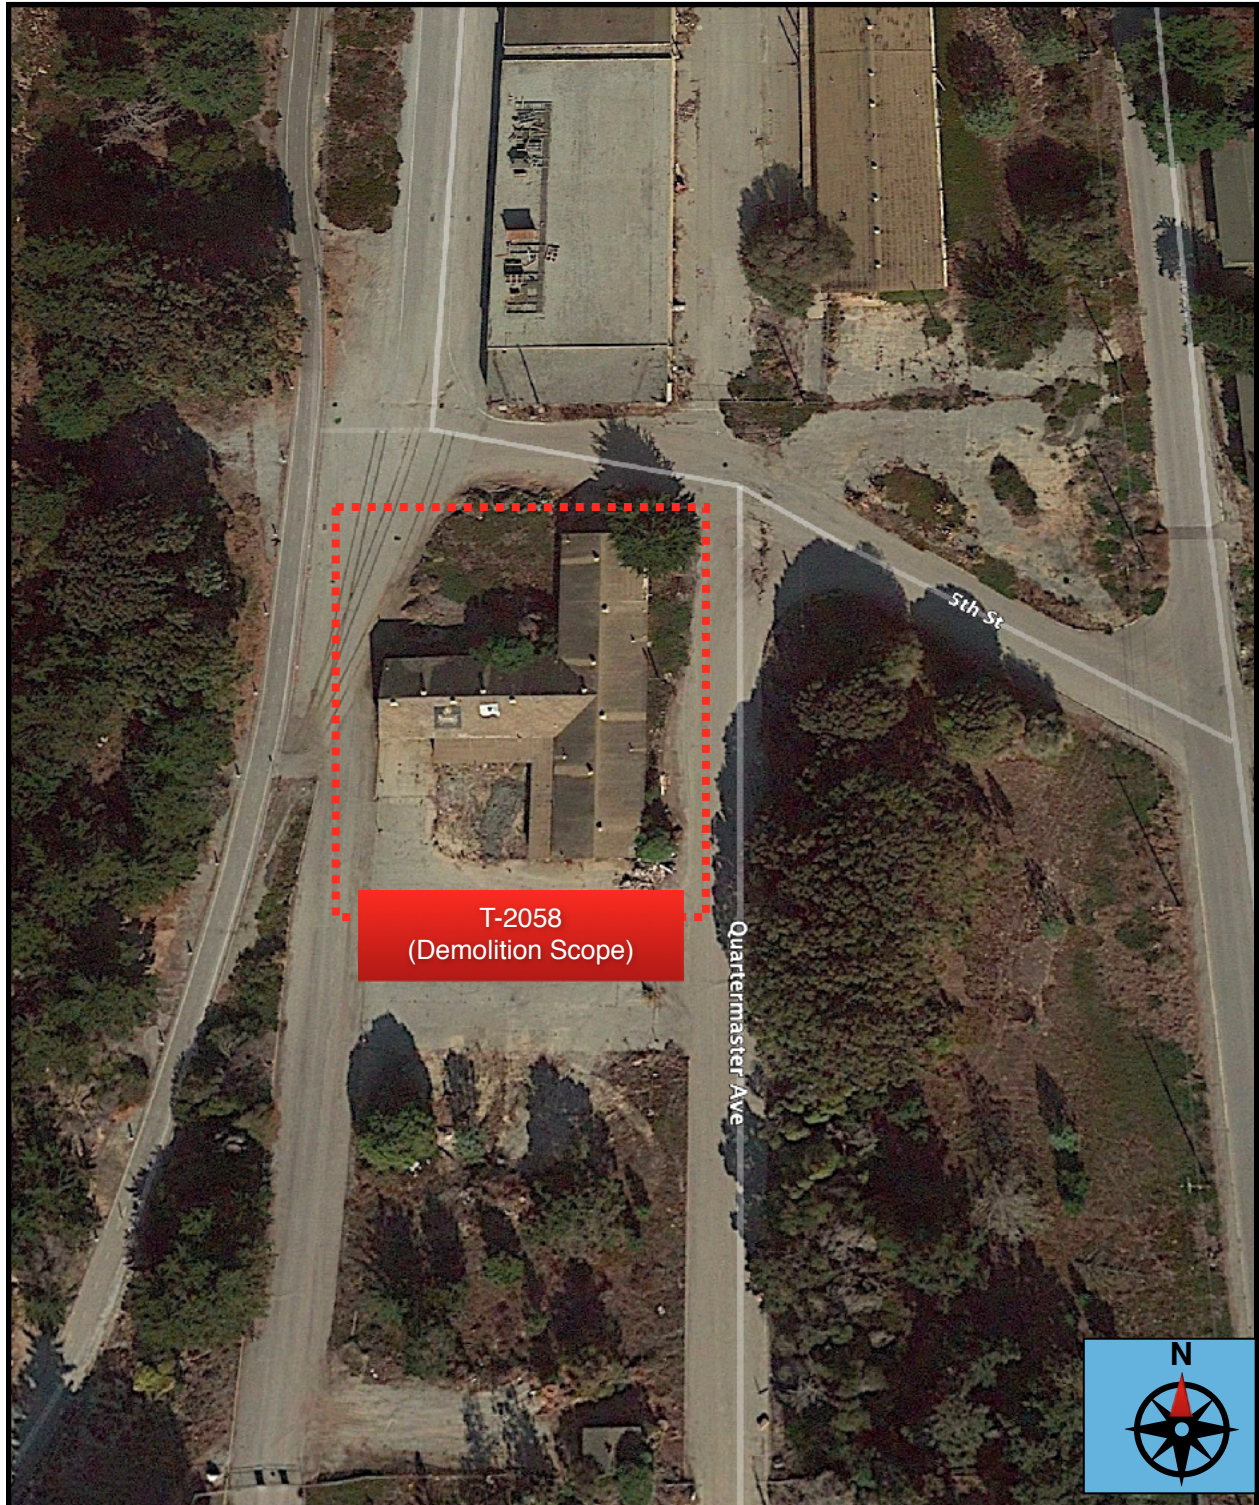
The subject site is the former Fort Ord military facility which was in use from 1917 to 1994. The building in the scope of this assessment was constructed prior to the 1940s. The structure has not been maintained and is in dilapidated condition. The fire department has also utilized the structure for training exercises, which has resulted in additional damage occurring.
